With this document are two sections dealing with the Bainter development project. First, is a selection of aerial photos and maps that have been prepared by Mr. Bainter and submitted to Planning Department Officials at the City of Yakima. Second, I discuss some issues dealing with environmental investigations at the State, Local and Federal Levels.

1. A location map for the so-called Bainter Habitat Improvement Project. While Mr. Bainter presented project materials to perform "habitat improvement", no such habitat improvement occurred. Also, the map for the project location describes an illegal access to the project site since Zoning Ordinance 14-2004

90th Avenue Shaw Creek Habitat Improvement

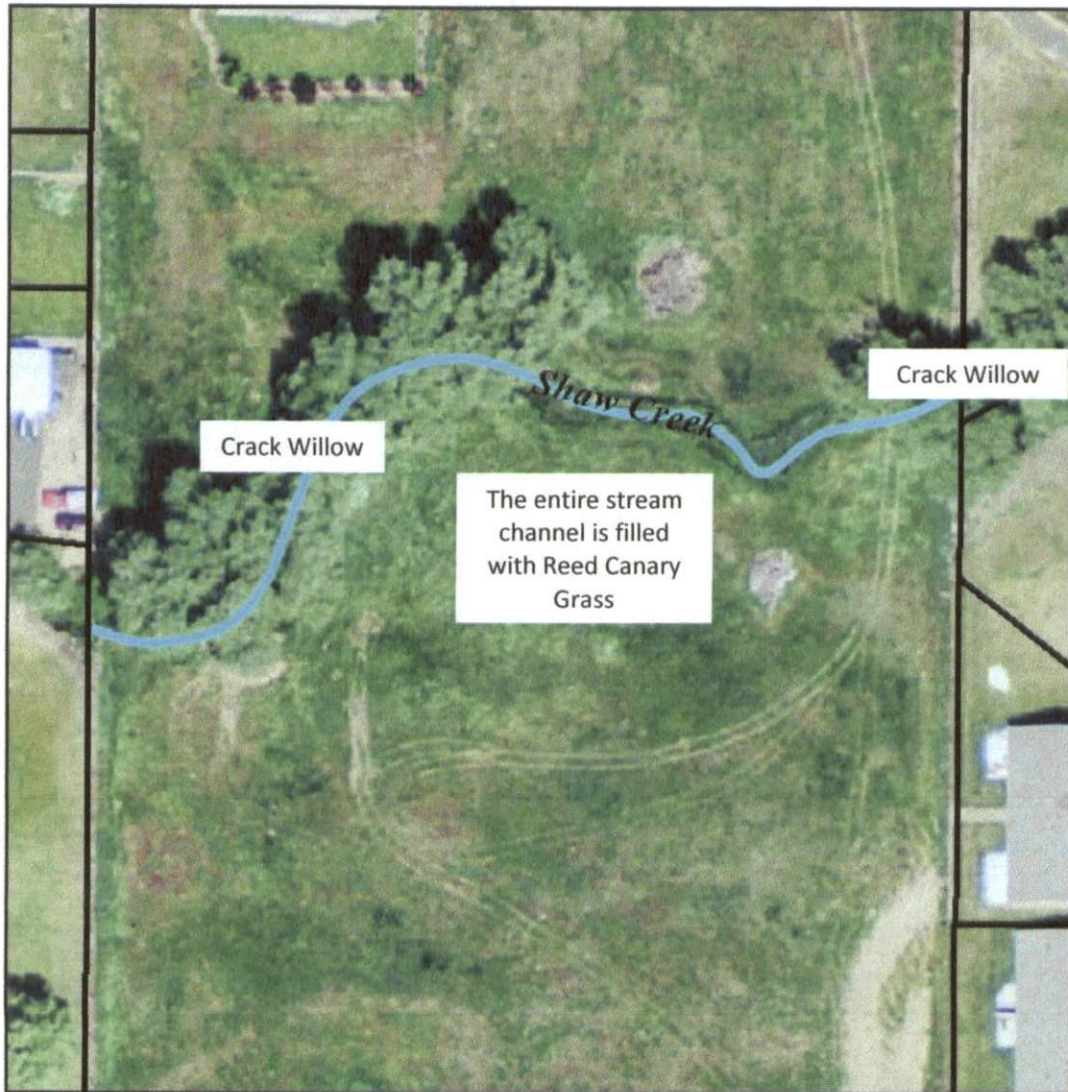
Attachment 1

Existing Vegetation

✓ ? not done

MR Baunter & MR Duxant show here
the correct, legal position of
Shaw Creek

2. Labelled "Attachment 1" by Mr. Bainter. This document shows the correct location of Shaw Creek. This location is defined by the mature Willow trees that line the watercourse. Also, a survey of 2011 defined the watercourse of Shaw Creek. At about the same time, formal mapping of Shaw Creek, the Shaw Creek Floodway, and the Shaw Creek FEMA 100-year Floodplain was performed by FEMA. The true location of Shaw Creek has been clearly defined.

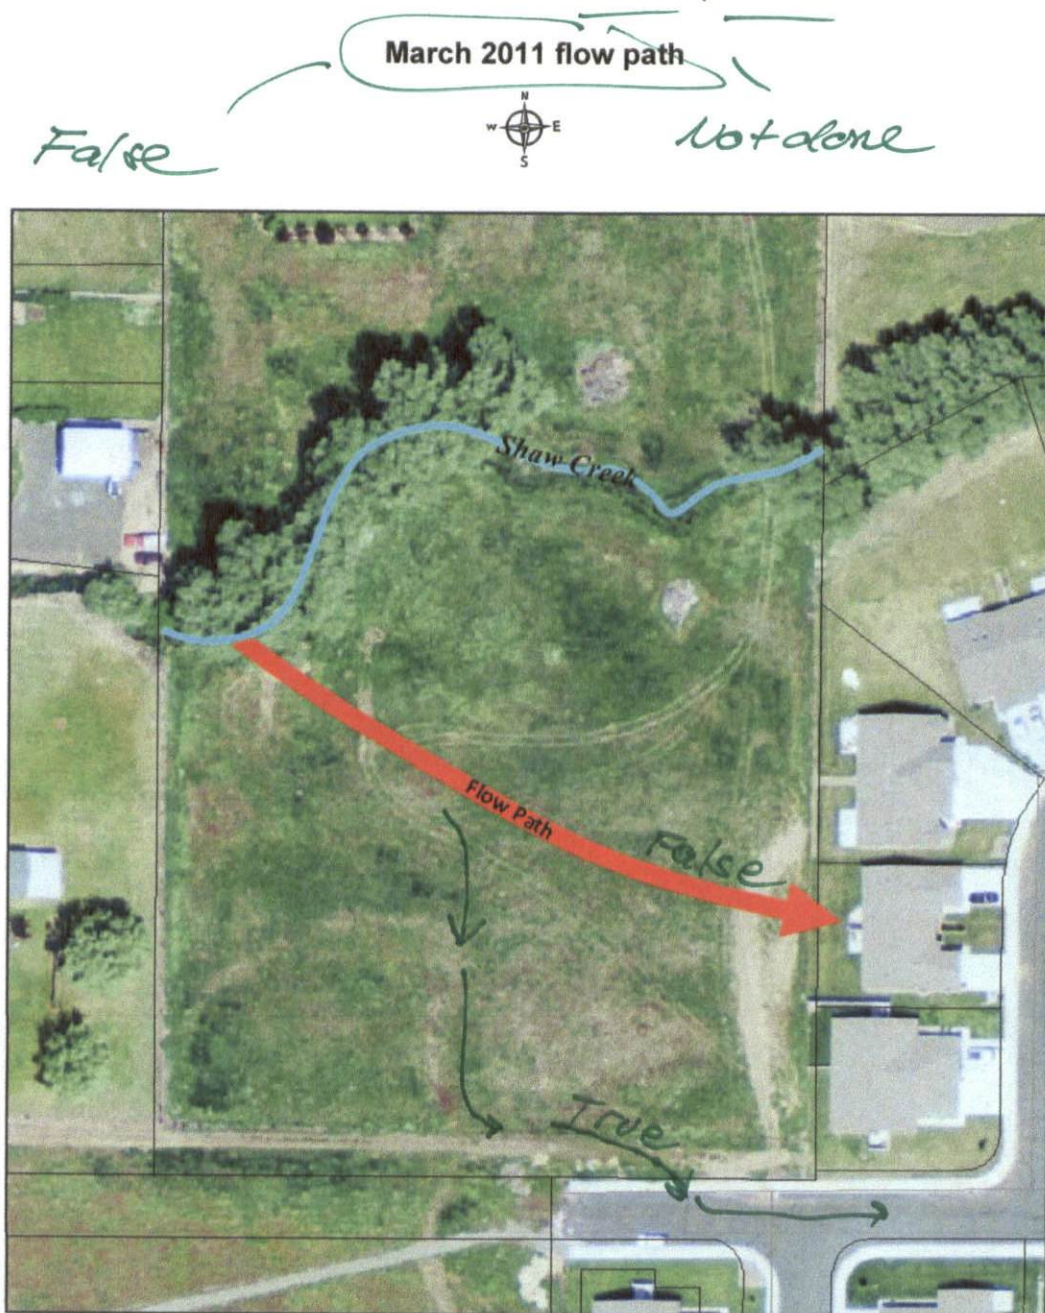
Attachment 2

A true flow path is in green.

The Red Flow path per Baister & Durant
has water flowing uphill into homes
located up and above the FEMA Floodplain

Not Done

4. Labelled "Attachment 2". Mr. Bainter presented this aerial view as a reason or purpose for excavating the "dry flood channel". Mr. Bainter indicated that water overflowed from Shaw Creek and then flowed in a path to the homes along the red line on the map. This red line is labeled "Flow Path". This so-called "Flow Path" begins with water flowing downhill, but then the water flow would be going up a slope towards homes that are located up and above the level of the stream. These homes are located above the Shaw Creek FEMA 100-year Floodplain. So, according to Mr. Bainter, water flowed uphill in March of 2011 in defiance of the laws of gravity. The annotated aerial photograph (Attachment 2) is false. Water does not flow uphill as indicated by Mr. Bainter. Mr. Bainter presented false and misleading information to reviewers so that he would receive a Critical Area Permit. Then Mr. Bainter used the Critical Area Permit to bring heavy equipment to the site so that he could perform preemptive habitat destruction in advance of commercial development.
